# Corrosion Damage and the Shear Capacity of Coastal Bridges

Gordon Holcomb, Steve Cramer,  
Bernie Covino, Jim Russell, Sophie  
Bullard, and Margaret Ziomek-Moroz

NWTC, Corvallis OR, 2/7/02

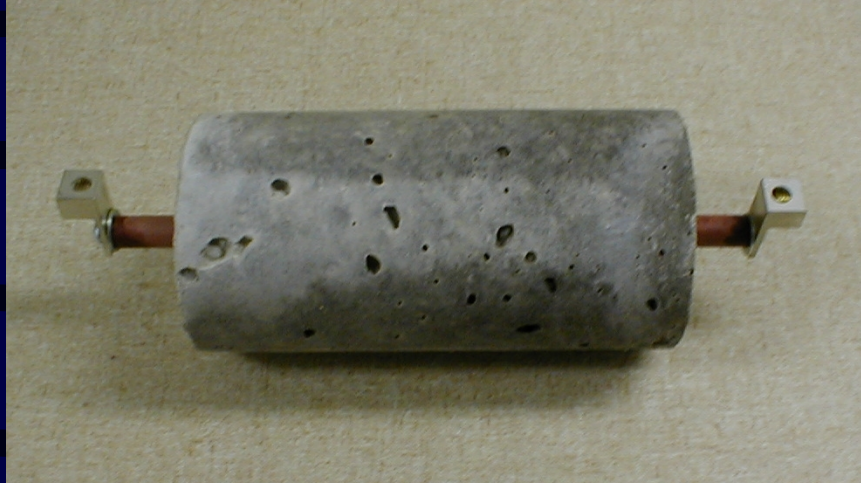
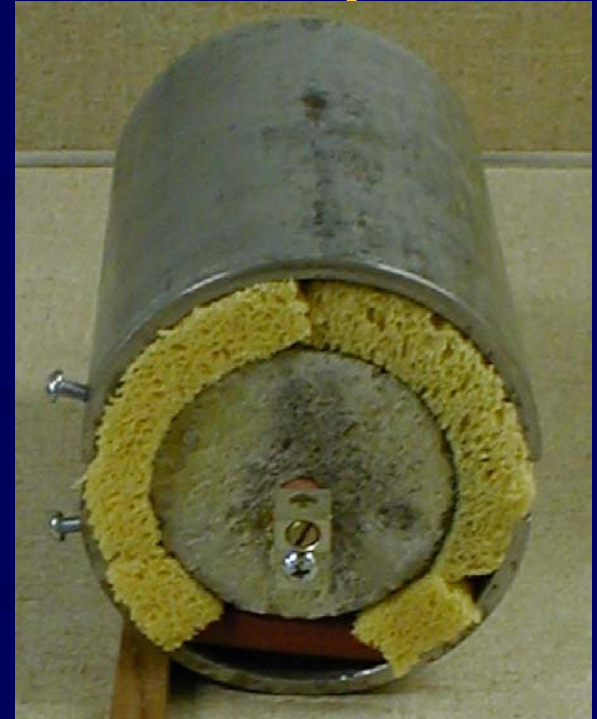
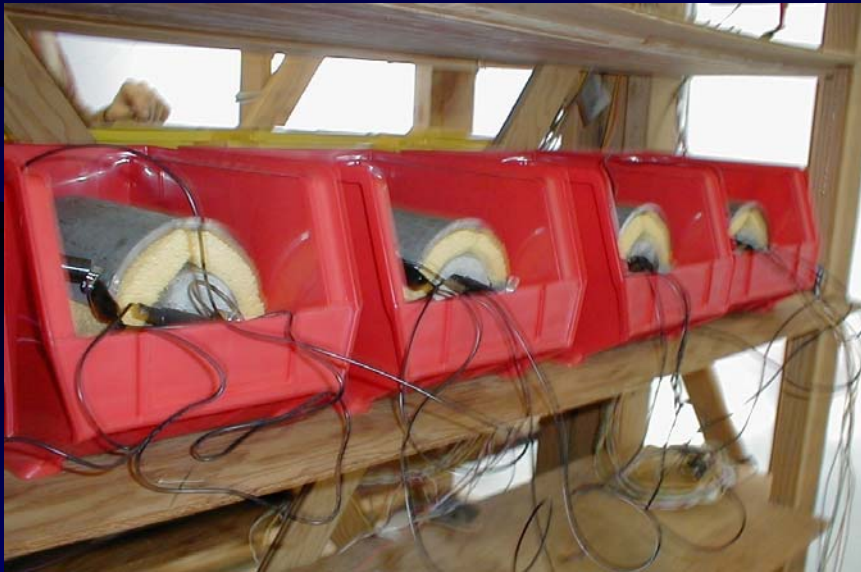
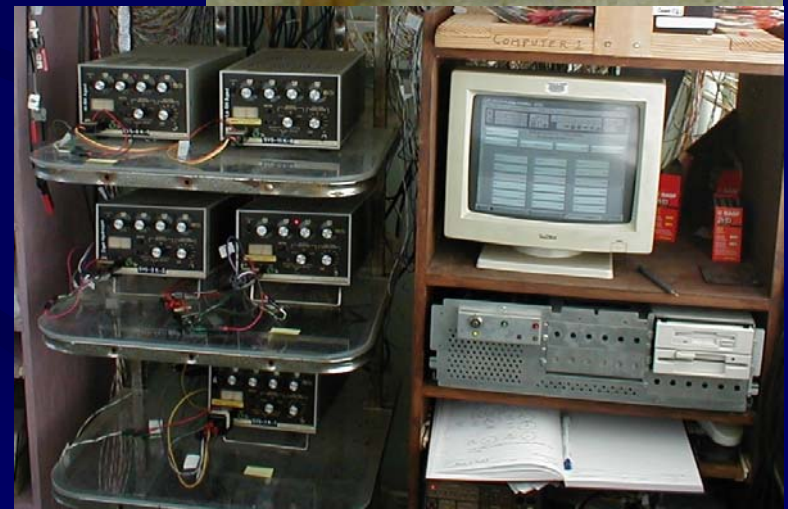
# Cylinder Corrosion - Setup

- Small cylinders corroded at 3 current densities of about 0.3, 0.6, and 1.7 mA/cm<sup>2</sup>
- Corroded to 4 different levels, between 10% to 80% section loss

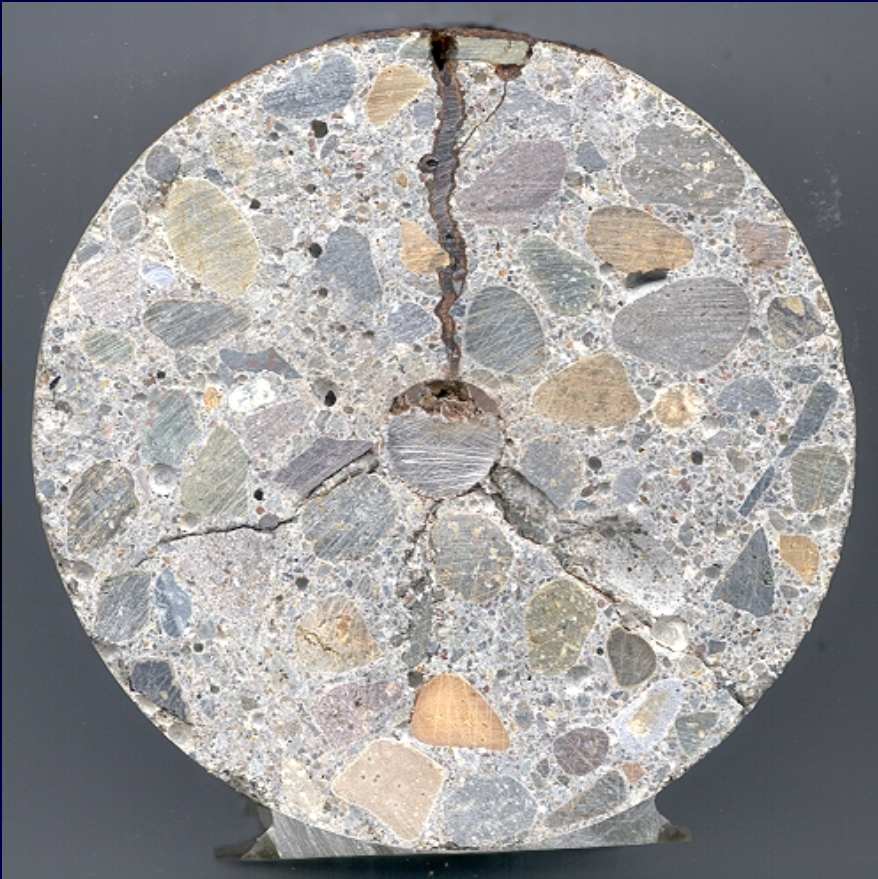
# Cylinder Cross Sections

## 31% Section Loss

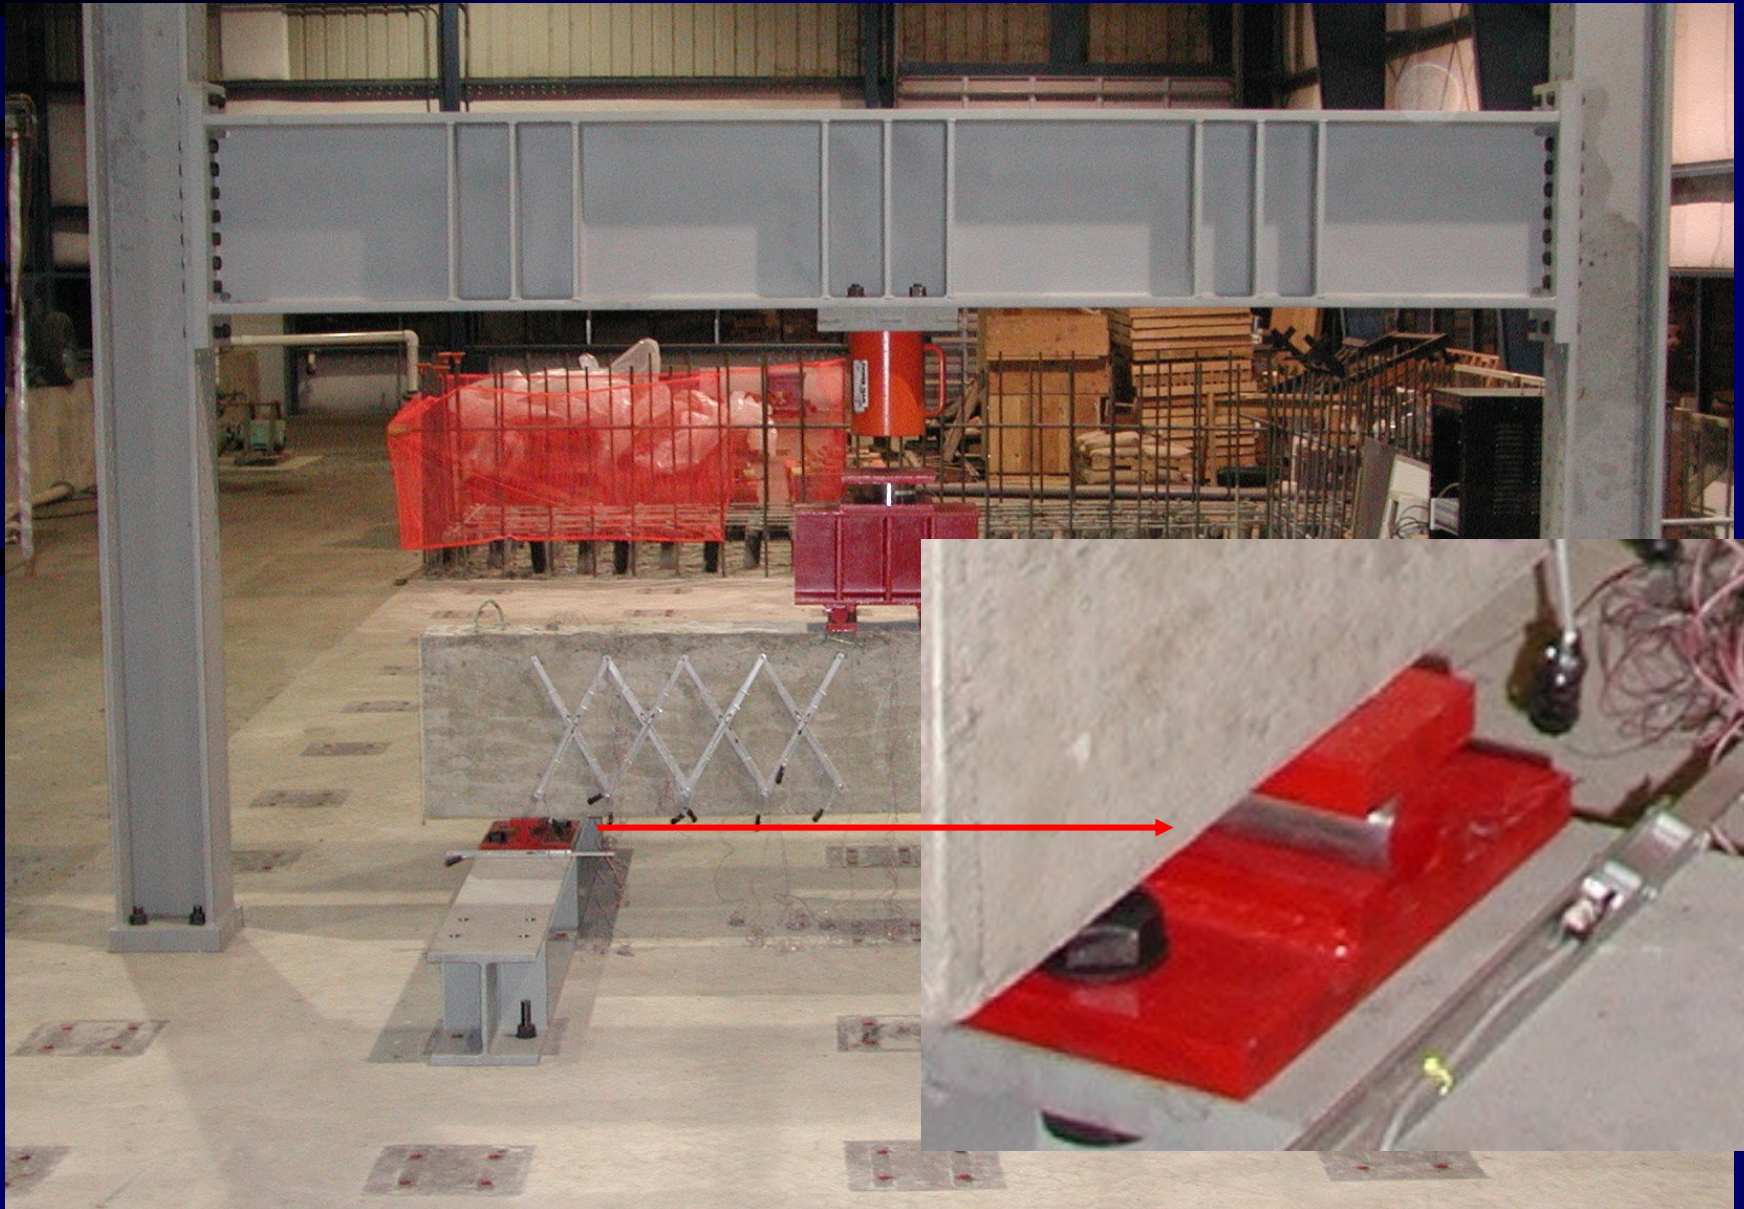
# Load Frame

- Destructive tests
- Beams simply supported
- Three point loading
- Instrumentation to measure
  - Applied load and deflection
  - Concrete and rebar strains
  - Crack width
  - Corrosion potentials
